Study of Deterioration and Conservation of A mosaic Pavement in the Baron's Palace, Egypt

Abstract

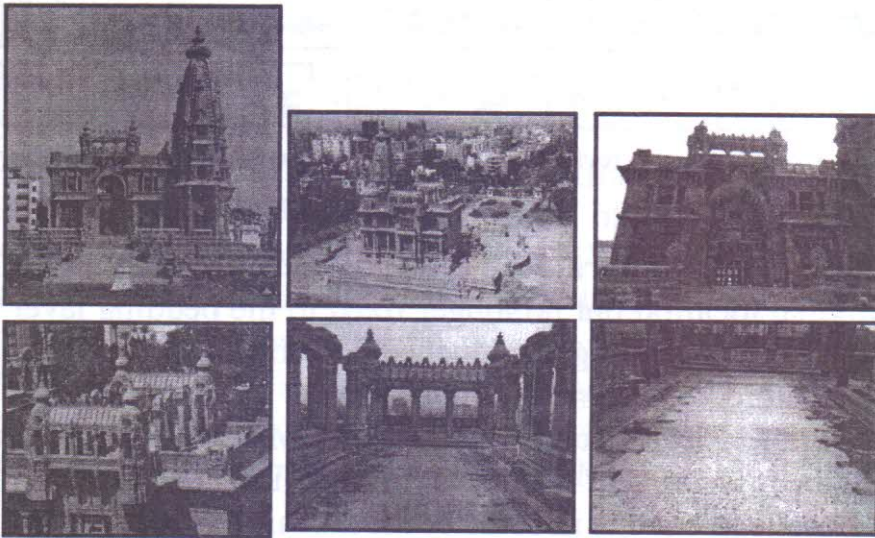
Fig. (1) Shows the Baron's Palace and the mosaic pavement.

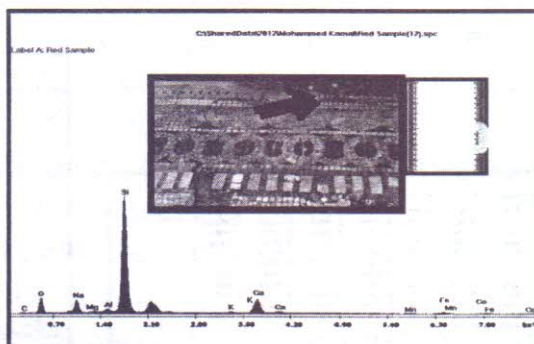
addition to potassium at ratio 1.01 % , fig. (7). On the other hand results indicated that the source of the white color in mosaic tesserae is calcium which used at ratio 12. 57 % and the source of flux is calcium in addition to traces of potassium at ratio 0.38 % , fig. (8). Related to results the source of blue color is copper at ratio 0.89 % in addition to cobalt at ratio 0.47 % and the source of flux is calcium at ratio 13.69 % , fig. (9). Finally, results indicated that the source of yellow color in mosaic tesserae is iron which used at ratio

Fig. (7) Shows EDX pattern of the red mosaic tesserae.

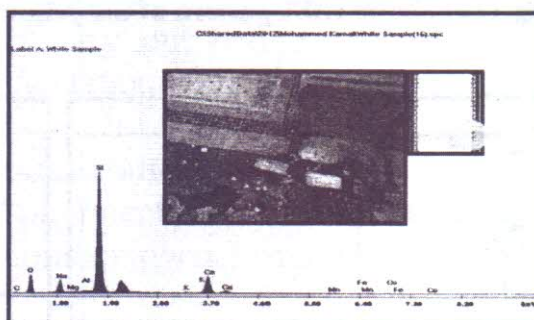
Fig. (8) Shows EDX pattern of the white mosaic tesserae.
