STUDY AND ANALYSIS OF DETERIORATION PHENOMENA OF DOUBLE FACED WALLS IN ISLAMIC MONUMENTS IN CAIRO, WITH APPLICATION FOR RESTORATION ON SOME SELECTED BUILDINGS

Dr.Sayed HEMEDA* ,Dr.El-Sayed EL-BANNA ,Dr. Ibrahim EL-EMAM*****

Two main case studies in respect of multiple leaf- masonry - walls are studied. The first one as an example for the bearing walls in historical buildings is Wkallah Radwan Bik Al-Fakari. The second one as an example for the retaining wall is Sultan El-Ghuri palace wall remains.

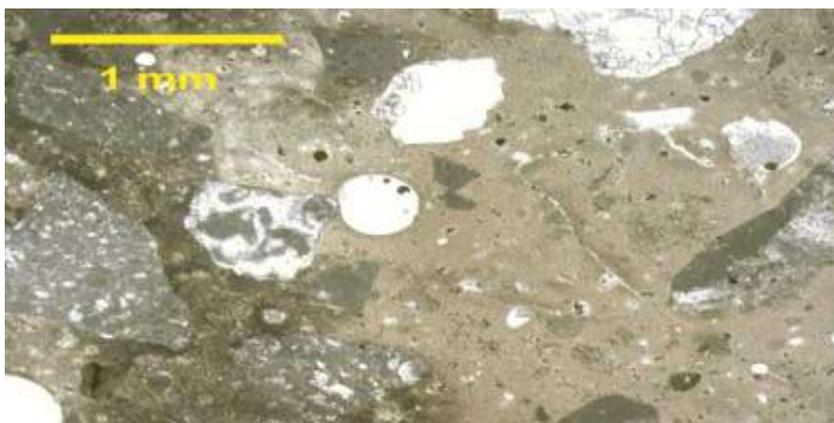
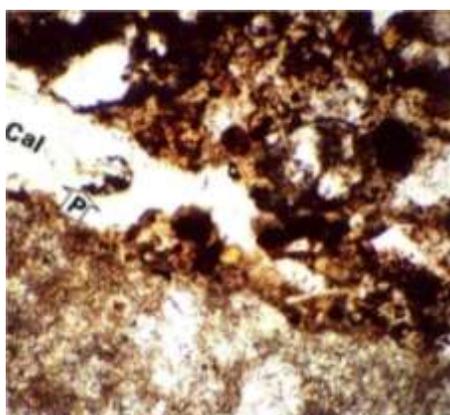
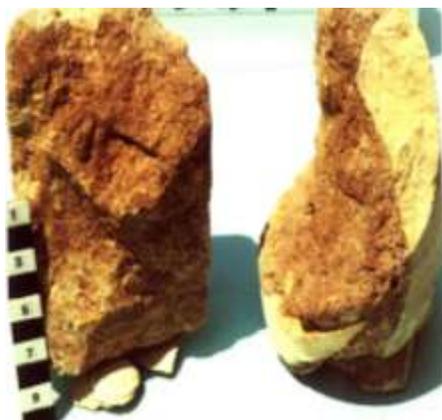
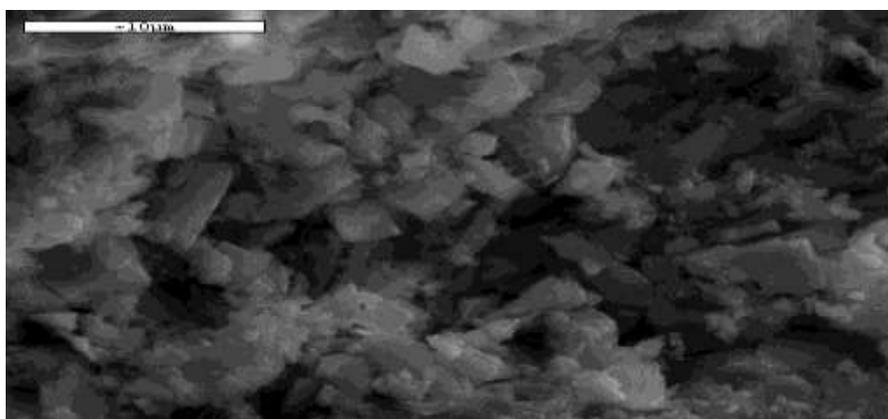
Thin section analysis indicates a great variety of silicate aggregates and the excellent bond between aggregates and paste in well compacted mortars of very good quality, figure (4).

Figure (4) Stereoscopic, polarizing and SEM microstructures examinations of the deteriorated core of rubble infill masonry walls under investigation.

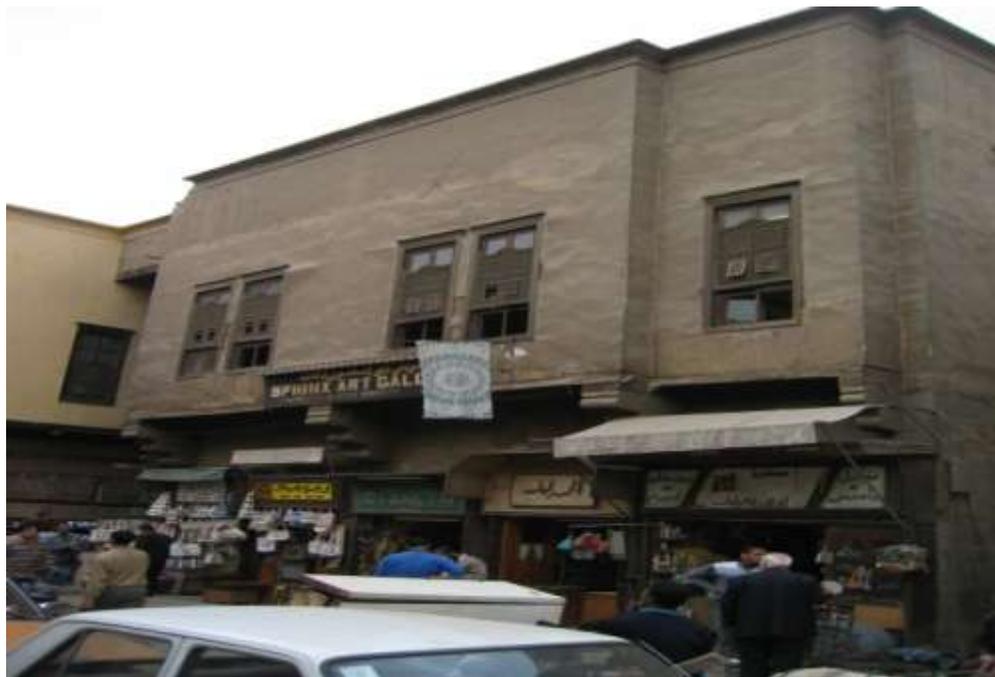
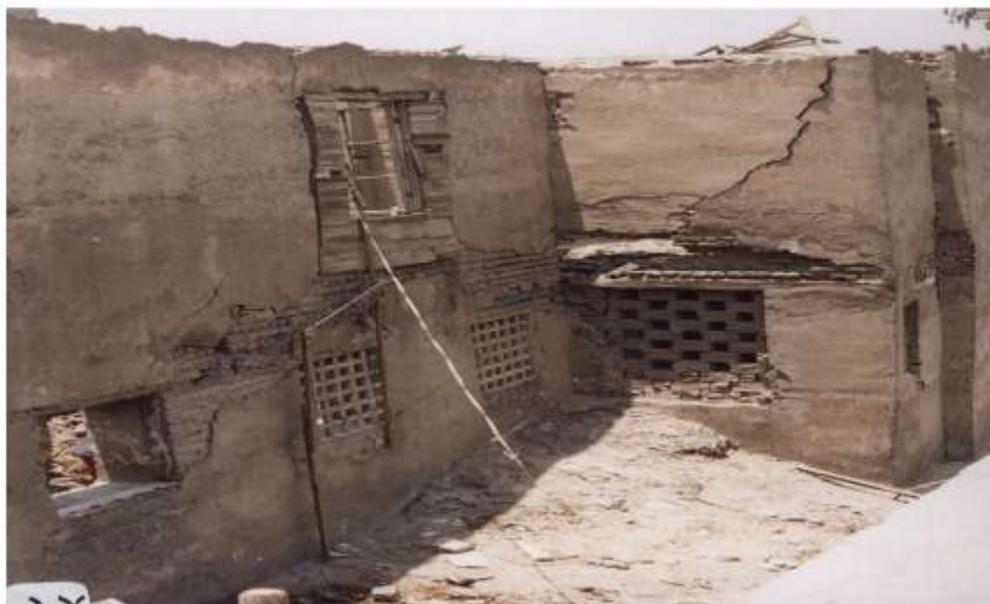
Figure (8). Present state of Wkallah Radwan Al-Fakari, before restoration processes.

- Most of the walls of the wkallah exhibit very severe fractures, as shown in (fig.8).
- Rising contaminated ground water table caused many problems for the foundations of walls, leading to uneven settlements of the foundations and structure.

- Sections of masonry have been demolished at ground floor level to create this additional space.
- Many cracks in the walls, as shown in (fig.8).
- Vertical and shear cracking patterns intersected the structures as shown in (fig. 8b).

- Many problems in arched and vaults, vertical cracks, fractured masonry and fallen key stones.
- Generally, the damage appears to be most severe on the east south elevation, the west elevation, particularly the North West corner and the four sides of the central courtyard.

- The north elevation and the east elevation appear to be little damaged (fig. 8a).

1. Improving the bearing capacity of foundations under the structures of the masonry by jet grouting techniques led to:
 - The capacity of the supporting elements and materials (jet grouting columns) would be able to take care of the whole weight of the monument.
 - The supporting elements would widely spread under the superstructures avoiding concentrated loads.
 - The supporting elements would connect each other and to the superstructures by R.C beams/ slabs to redistribute loads and to give confinement.
 - The existing shallow foundations would be improved by low pressure injections of cement grout.
2. It is necessary to be introduced stitching system to tie the elements of the superstructure together.
3. Double faced walls should be gravity grouted to ensure that any voids which exist are filled with lime grout.
4. Intervention on deteriorated stones and external surfaces.

5. Restoration of cracks in walls.
6. Restoration of connections between walls.
7. Interventions on floor and roof structures.
8. Interventions for waterproofing.
9. Intervention for facades.
10. Intervention for internal arches.

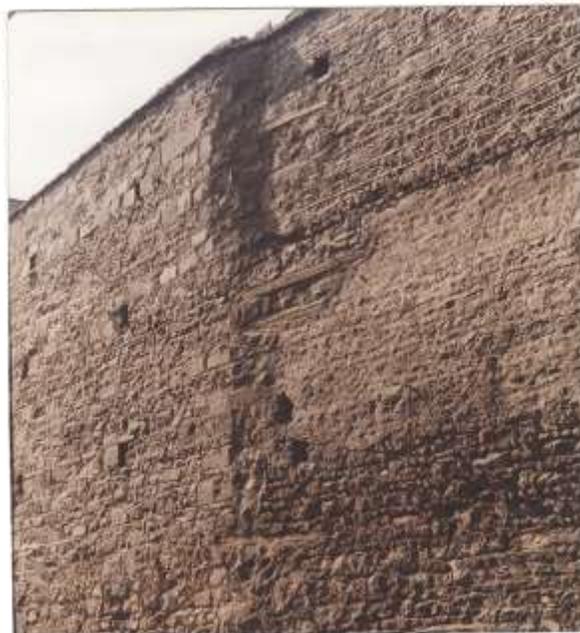
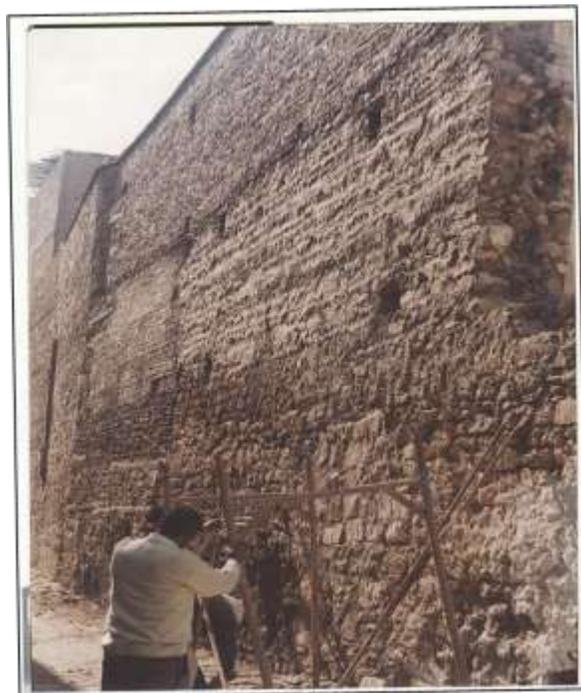
Figure (11). Present state of Sultan El-Ghuri palace wall remains, before restoration processes.

- The observations of the damage of the wall as following:
- Tilting and settling of wall.
- Separation and open cracks at the connection of wall with stable areas. This major crack is much wider at the top than at the base.
- Settlement and movements of wall blocks at the 2 sides of the cracks.
- Vertical crack at the 1/3 of wall, starts from the top in joints of blocks one crack while become two cracks on the bottom and it have outer displacement about 1.5 cm.

- Horizontal cracks on the platform level behind the outer wall and parallel to it.
- Deterioration of lime stone masonry of wall as in (fig11 and12).

The main evidences of the stability problem, still in evolution, are: Tilting and settling of wall which causes open cracks at the connection with stable areas not involved by the phenomenon; the major crack is much wider at the top than at the base.

- Cracks on the ground behind the wall and parallel to it that indicate the presence of tensions in the backfilling material at the rear of the wall; this affects the structural integrity of constructions built nearby the massive retaining wall.

2. The reconstruction processes started by improving the stability of the massive retaining wall by low pressure injections for filling strata of soil up to 10 m below ground level and making new steel reinforced concrete strip foundation forming a wide and deep foundation base under the high bearing capacity to stop tilting phenomenon and give adequate factor of safety against further seismic events;

of cracks in walls, vertical separation and open crack at the connection of wall with stable areas. Restored the horizontal separation crack on the platform level with adjacent old building. Interventions on floor of platform.
