RESTORATION AND PRESERVATION OF ENGRAVED LIMESTONE BLOCKS DISCOVERED IN ABU MOUSA EXCAVATION, SUEZ- EGYPT

Abstract:

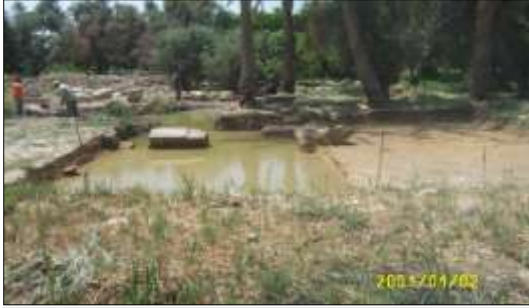
Figure 1 shows the Abu Musa Excavation during 2001 season.

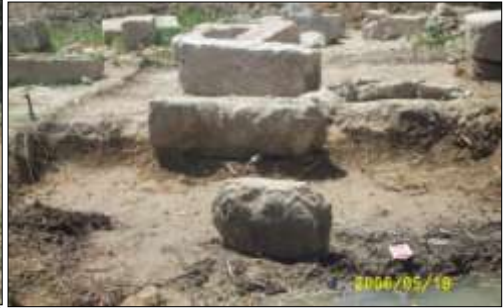
Figure 2 shows the Abu Musa Excavation during 2006 season.

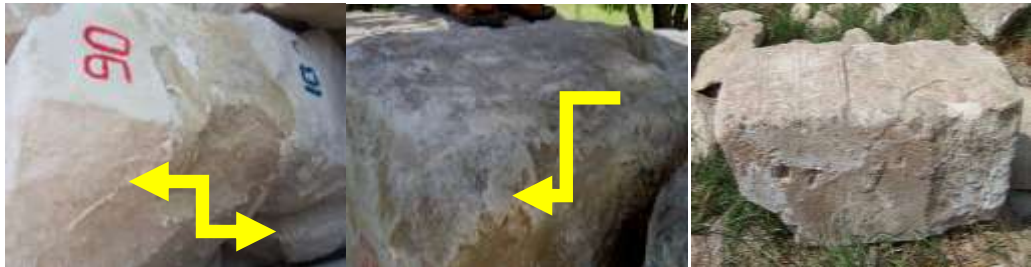
Fig. (3a,b) crystallization of different salts to light-colored crust tracing the surface and between layers of engraved limestone.

Fig.(4) loss of cohesion between grains caused the current detachment of individual grains.

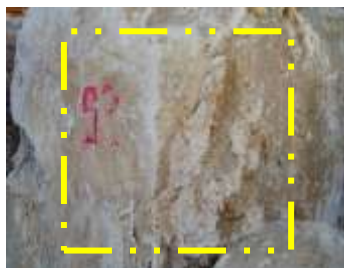
Fig. (5) Crystals of soluble salts pushing off a surface layer of stone.

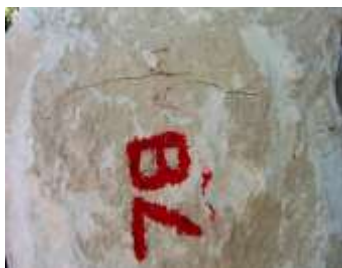
Fig.(6) shows the cracks and microcracks.

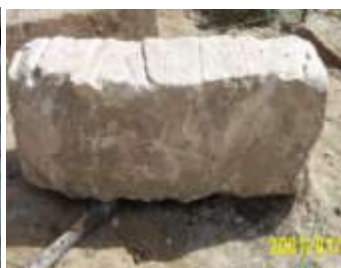
Fig. (7) powdering/crumbling of the engraving stone due to salts efflorescence.

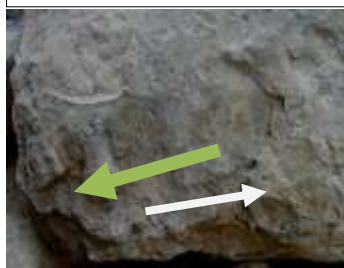
Fig. (8) Exfoliation of the engraving limestone in Abu Musa Excavation.

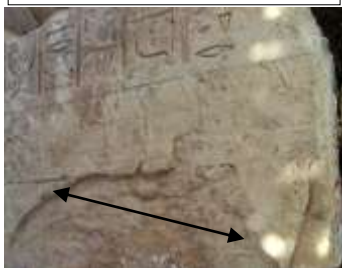
Fig. 9 shows the disintegration of the engraving limestone.

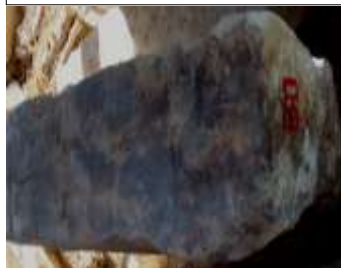
Fig. (10a,b discoloration of the engraving limestone in Abu Musa Excavation.

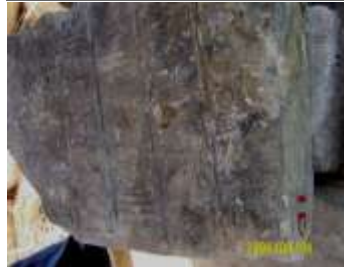
the accumulation of black to dark-colored crust tracing the surface and brown, green and white stains of microorganisms caused the discoloration of stone surface (fig.11). Black rust was found in the surface of some limestone blocks (fig.12). All stone blocks surfaces were covered with thick clay layer with soil particles and vascular plants. Roots are growing which disfigured them and hid their reliefs (fig.13). The deterioration caused by plants is both mechanical and chemical. In this case the chemical action is influenced. The chemical action is due to the acidity of the root tips and the acidity and chelating properties of the exudates. Certain plants, for instance ivy, can also cause a change in stone color as a result of the release of organic compounds ⁽⁵⁾. Also the main weathering forms characterizing deposits on the stone blocks were the growth algae. These are in fact extremely simple plants which live in very damp places or in water. They appear as greenish or brownish slimes or suspensions in water; a sudden increase in their numbers gives a dense bright coloration known as a bloom (fig.16).

Fig. (11) Microbiological colonization to dark-colored crust tracing the surface of reliefs.

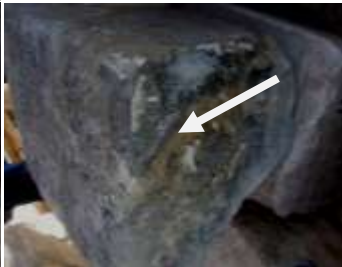
Fig. (12) Black rust found in the surface of some limestone blocks.

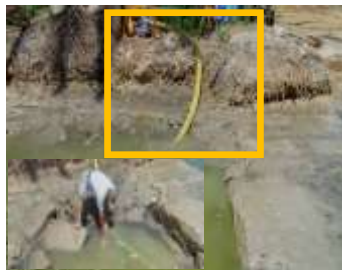
Fig. (15) The process of water suction suddenly from the area of Abu Musa

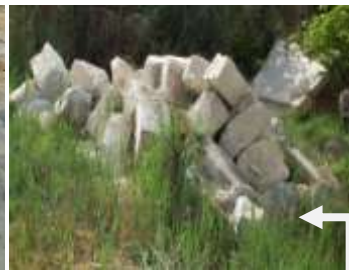
Fig. (16) Wrong storage between grass and areas of high humidity

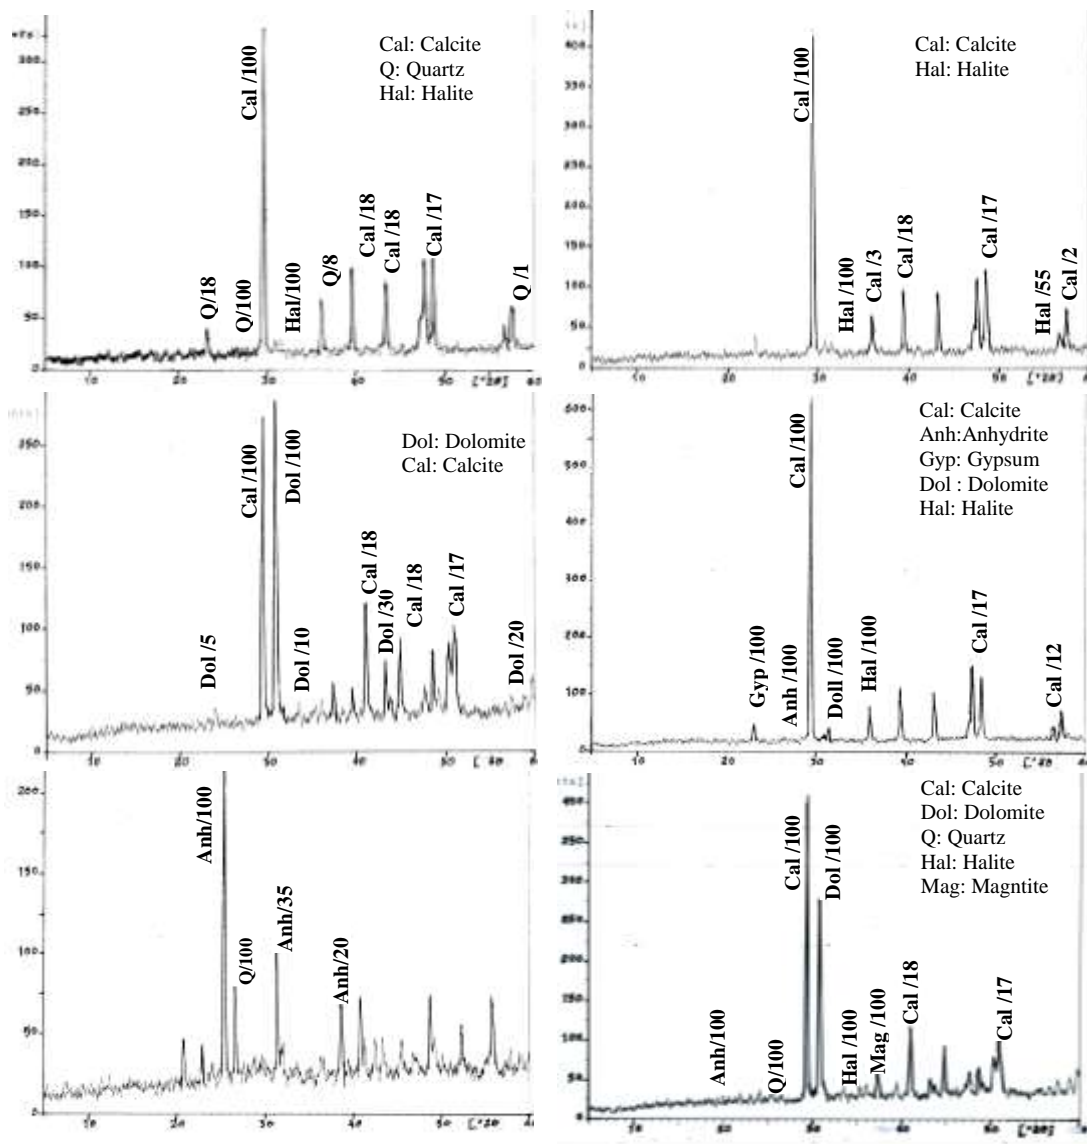
The XRD analysis of studied samples (the results are summarized in table 2 and figure 19) have shown that the, the sample consisted essentially of calcite CaCO_3 , Dolomite $(\text{Ca,Mg})\text{CO}_3$ and small amount of halite NaCl , Quartz SiO_2 , Gypsum $\text{CaSO}_4 \cdot 2\text{H}_2\text{O}$, Anhydrite CaSO_4 and traces of iron oxide and Orthoclase KAlSi_3O_8 .

Fig. (20a- g) show the XRD patterns of investigated limestone samples.

The mineralogical analysis using XRD of the limestone samples have shown that, the salt layers consists mainly of halite and phases of sulphates (gypsum and anhydrate). The halite salts related to groundwater salinity from Sues Canal and cultivated land. Gypsum was produced by the reaction between the SO_4^{2-} ions present in the acid deposition and the calcium carbonate (CaCO_3) present in limestone or perhaps it is a natural mineral in the stone, it is generally found in Abu Musa limestone in the form of dehydrated sulphate($\text{CaSO}_4 \cdot 2\text{H}_2\text{O}$) Gypsum and Anhydrate (CaSO_4). The most important source of sulphate is atmospheric pollution, Agriculture land as Abu Musa region, sea sprat from Suez Canal and micro-organisms. Transformation of Gypsum to anhydrate by heating in summer causes a great change in the volume of the crystal of gypsum which decreases when transformed to anhydrite resulting in many cracks and microcracks in blocks, gypsum loses water after reaching 42°C transforming into Anhydrite. So, the most common damaging salts consist of sulfate and chloride anions. The problem is more complicated by the existence of aluminum and Quartz may be attributed to the clay minerals. The SEM photograph documented these results. Also iron oxide is found in the samples as traces minerals; it could be argued that the fracturing form affected the samples exposed to salty bath contains due to the presence of the Fe ion, which leads to the creation of sever deterioration forms. These forms are due to the effect of alternative cycles between hydration and crystallization pressures created by the effects of contact with the oxygen and moisture in the open environment. This cycle leads Fe ions to change into hydrous iron oxide (the density is 7.8) which occupies a much larger volume than the parent Iron (the density is 3). This difference leads to the pressure generated in the confined spaces by this volumetric increase is large enough to fracture the stone⁽¹¹⁾.

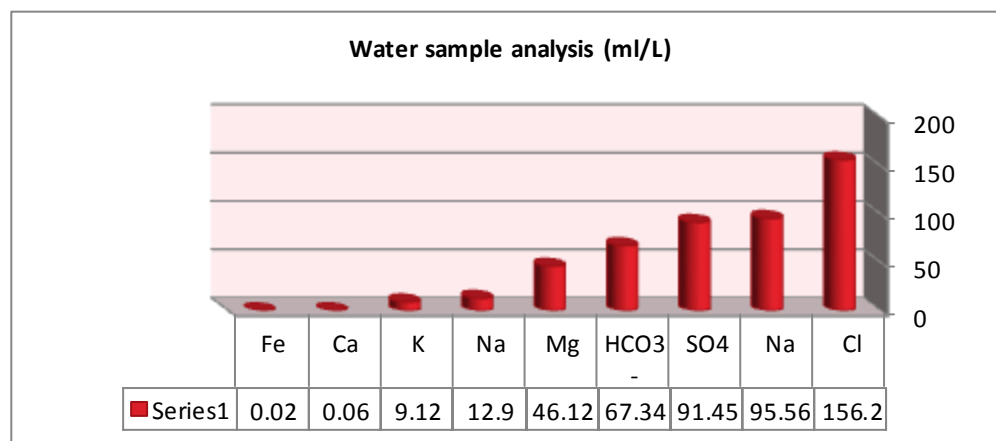
The chemical analysis of the water samples (the results are summarized in figure 23) showed that it is rich in sodium (Na⁺), chloride (Cl⁻), potassium (K⁺), magnesium (Mg²⁺), nitrate NO₃⁻ and calcium (Ca²⁺) ions. The water also has a high content of bicarbonates (HCO₃⁻) and (Cl⁻), sulphates (SO₄⁻). PH was 8.2 and the temperature was 26°C, (fig.23).

Fig. (23) The chemical analysis and ASS results of groundwater analysis from Abu Musa.

Chemical analysis showed that the water sample is very rich in Sodium (Na^+), chloride (Cl^-), potassium (K), magnesium (Mg^{2+}) and calcium (Ca^{2+}) ions. The water also has a high content of bicarbonates (HCO_3^-) and sulphates (SO_4^{2-}). Sample from groundwater was analyzed for comparison with the samples from the stone blocks to see how much the water had affected them, The analysis of several stone blocks and salt samples showed similar results and the presence of the same salts in addition to percentage of sodium and chloride, which are contained in halite, sulphate, potassium, magnesium and calcium related to the presence of gypsum and anhydrate. The results in the present study proved that the engraved stone is affected by the water of the nearby canals (Ismailia and the Suez Canal represent the main source of water in the Abu Musa area).

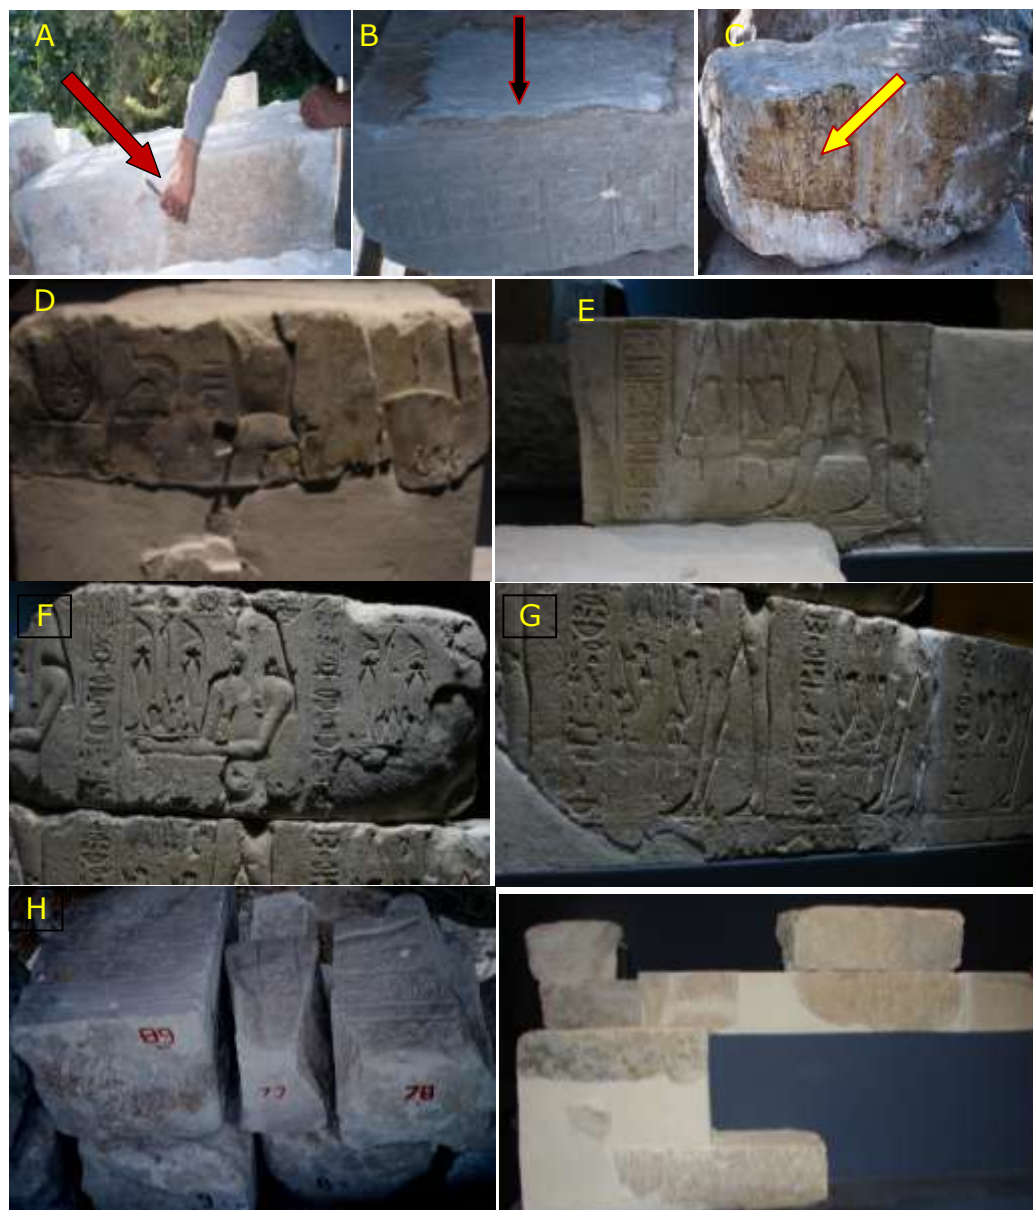
Figure. 23 restorations steps of stone blocks (a) mechanical cleaning (b) absorbent poultices (c) the stone block after poultice. (D,E) Completion of missing parts (E,G) Re-jointing the stone blocks, (H) the blocks after restoration in Excavation field (I)the exhibition of stone blocks at Suez museum.

The friable dirties were firstly cleaned mechanically from the surface by using soft brushes and rough brushes with different size advanced to metallic spatulas and scalpels carefully without any damage occurred. Where dirt is particularly ingrained, distilled water with ethyl alcohol was employed by absorbent packs. During mechanical cleaning it was found that some deteriorated scene surfaces were so weak that application of any cleaning process would result in the loss of large amount of scene. Primary consolidant of separated weak surface by using 2% Paraloid B.72 "by spray methods" to consolidate this weak parts and then cleaned.

Chemical cleaning (wet cleaning) was carried out to remove what mechanical cleaning failed to remove. Ingrained dirt, unsightly patchiness and blackened crusts of calcium sulphate were cleaned using two poultices, the first one was absorbent poultices loaded with mixture of 10% sodium thiosulphate ($\text{Na}_2\text{S}_2\text{O}_3 \cdot 5\text{H}_2\text{O}$)

blocks were collected and grouped to obtain an accurate profile of a relief or design, so as to be displayed and to keep contiguous blocks together to avoid further abrasion during storage. Re-jointing and linking of these blocks were carried out by using lime mortar only, consisting of 1 lime + 2 fine sand mixed with 20% primal Ac33 and then complete the missing gaps and spaces with the same lime mortar components. The mortar was applied by a spatula to flatten the putty and smooth it out until it comes well to the edges of the stone surface. The last mortar had very fine-grains and its level was less than the level of the existed archaeological surface according to the known restoration rules. Wood stand was designed for the exposition after completing restoration processes in Suez Canal Museum.
