**METHODS OF CONSERVATION AND RESTORATION  
SOME PHARAONIC INSCRIPTIONS PRESENTED ON  
SAND STONE WALLS OF LUXOR TEMPLE INSIDE  
ABU EL-HAGAG MOSQUE, LUXOR- EGYPT**

**Dr.Anwar F. Mahran**♦

**♦♦Dr. Abd El-Hadi Mohammed**

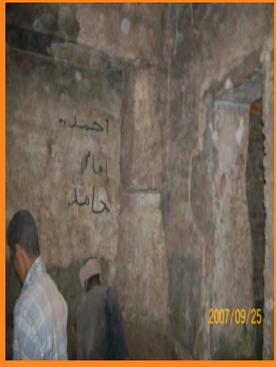
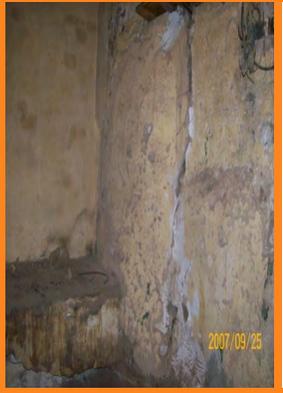
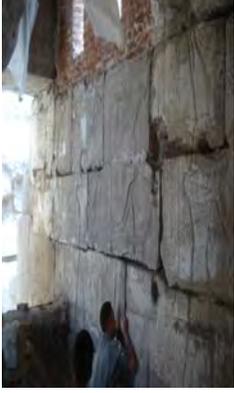
**Fig. 3**

<p>a- The walls of the temple and mosque disappear under layers of grout</p>	<p>b- Layers of grout block separating the original parts and the added parts</p>

<p>c- Layers of grout hide traceability paths cracks in structural elements</p>		<p>d- Texts and Inscriptions columns distorted and blurred the bottom layers of grout</p>

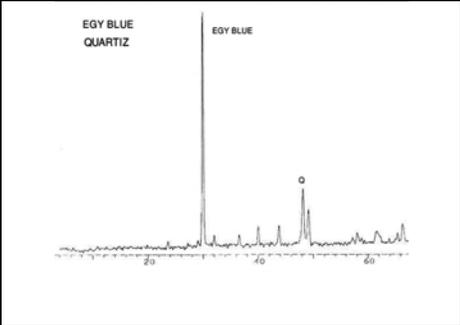
<b>Egyptian blue</b>	CACUS I4O10	63.40 %		Lint el	Bl ue
	<b>Quartz</b>	SIO2	36.60%			
<p><u>X.R.D RESULTS</u></p> <ul style="list-style-type: none"> <li>▪ Yellow occur pigment is Goethite.</li> <li>▪ Blue pigment is Egyptian blue.</li> <li>▪ Rendering and plaster is gypsum</li> </ul>						
<b>Fig. 5</b>	Forms and tables x-ray diffraction of different samples

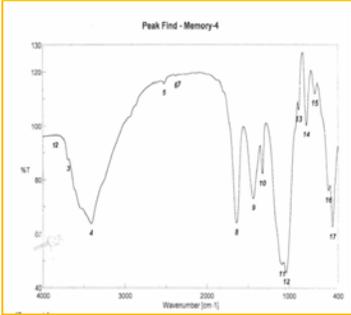
SAMPL E	RESULT S	NOTES	
yellow -occur	Animal glue used as (organic binder)	The chart explained that there are deterioration in the binder (totally obvious in the group which represent the binder components)

<b>Results:</b> animal glue used as a binder in the two pigments. There are deterioration in the binder.			
<b>Fig. 6</b>	Some samples were selected and studied by infrared spectroscopy

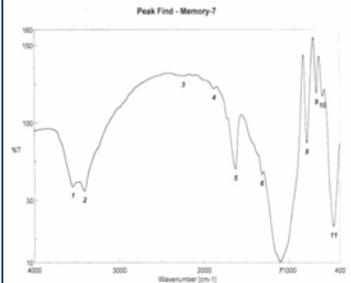
blue pigment.	Animal glue else	There are group represent malachite and other traces

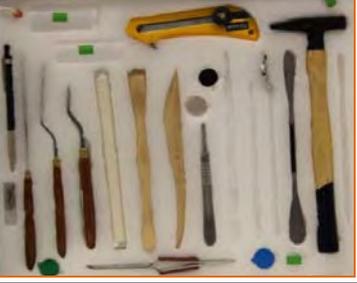
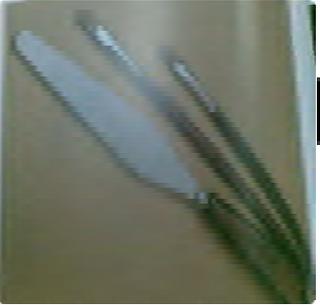
**Fig. 11**

<b>a-</b> Number of manual tools (wooden stick and the scalpels)	<b>b-</b> Brushes and knives and measurement tape	<b>c-</b> Hammer and Palette

<b>d-</b> Some of important mechanical cleaning tools and its spray water need the softening

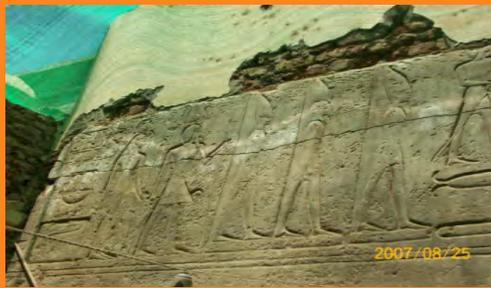
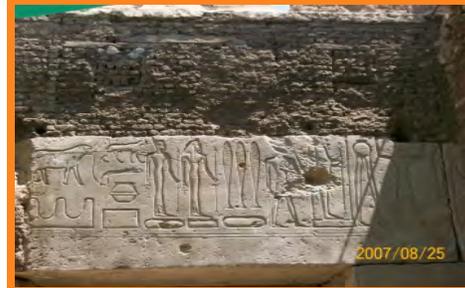
<b>Fig. 12</b>

<p>The most important results of the cleaning showing relationships between items and identifying structural elements and components that helped in drawing features of architectural restoration project after that (Columns, Lintels, Mud brick, Plasters)</p>	
<b>Fig. 13</b>

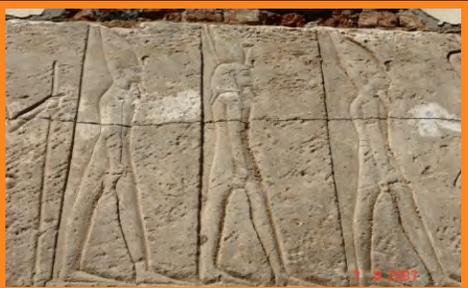
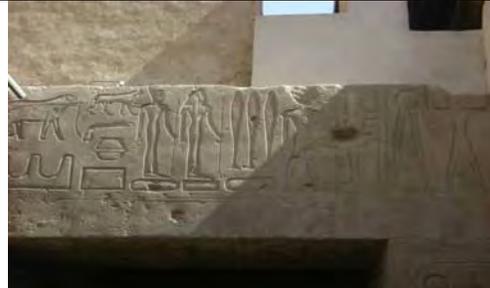
<p><b>a-</b> Surficial cracks in sandstone mural Painting appeared after discovering</p>	<p><b>b-</b> final mechanical cleaning result</p>

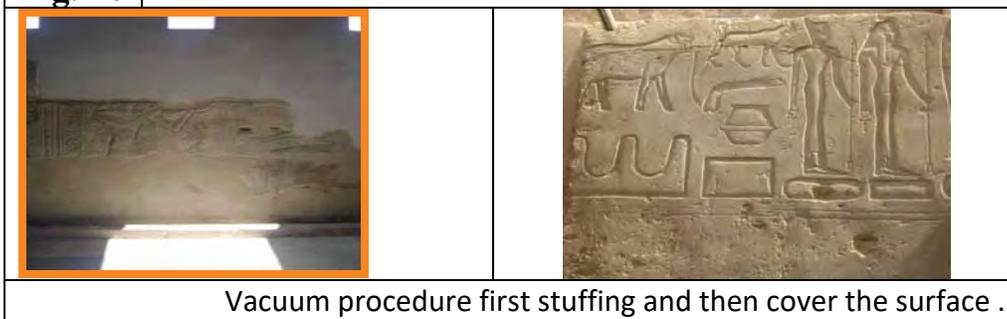
**Fig. 16**

Cracks in the walls were italic, vertical and separatist, and the Latest was more serious because the slash limit the ability of the wall to carry vertical loads echanical Fillers reconstructs the same structural pieces in rift zone

**Chemical Fillers** some chemicals improvement in characteristics of mortar to structural role in Filling of gap linking both sides of Crack simple parts (just cracks and gaps were filled with broken stone , washed lime, white cement and Coarse sand in proportion 1: 1: 3 and then cover the surface by layer of mortar made of lime white cement + soft washed sand and of 1: 1: 3, with the lower surface .

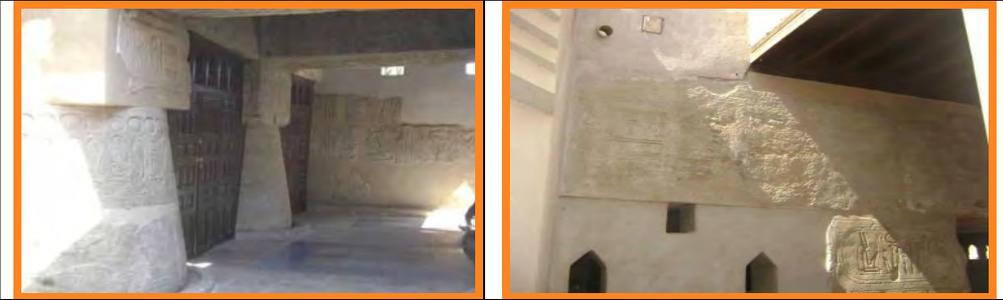
**Fig. 17**

Interior spaces after restoration and Photos show the beauty of architectural composition of the temple and overlapping structural elements with the walls of the mosque.

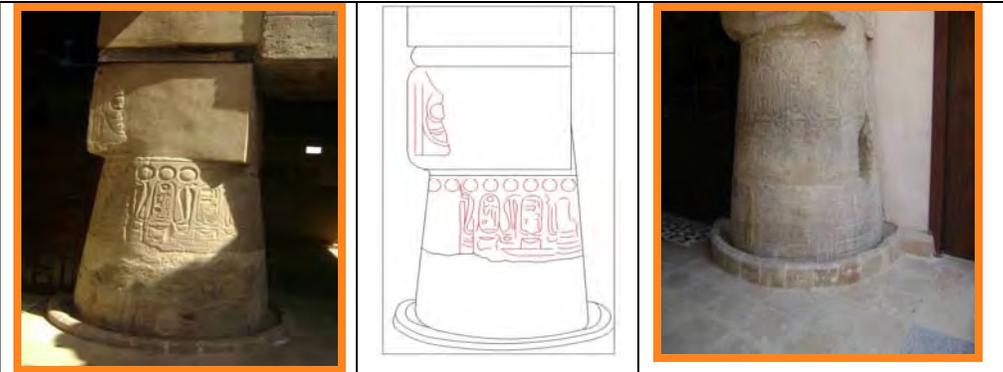
**Fig.18**

Restoration of columns, complete the missing parts, paving of Grounds and protection of Ends

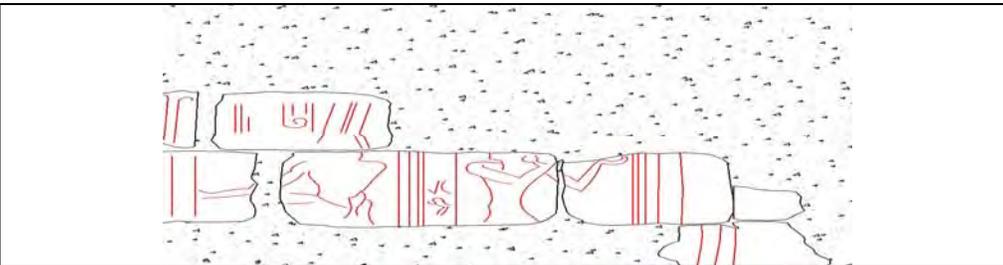
**Fig. 19**

Interior spaces after restoration and Figures show the Rate of spaces between the Original areas and crushed areas.

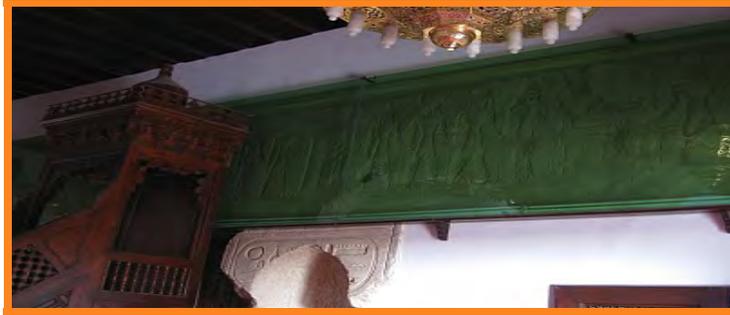
Fig.20

So found a creative and sensitive solution to expose the pharaonic images for public Lights behind the glass can illuminate the images more clearly on request.

The main aim was realized by remove the grout and the mortars introduction on texts and inscriptions, which had remained hidden for too long, today there is no wrong or worse or than a prayer in environment surrounded by painted walls and there is no creation and graphics return was to appease the interactive civil society with the mosque hide temporary mural linear top iwan of Qibla only during prayer.

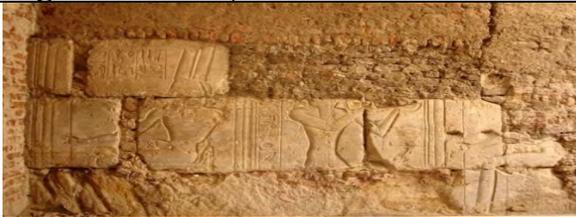
<b>Fig. 21</b>

a- A part of a damage scene represents a king (the head is disappeared) offers mDt-offering to the god Amun. A part of a frieze The beloved of Amun-Re who gives life.	b- The two ladies protect10 Egypt and beat down the foreign countries.
<b>Fig.22</b>

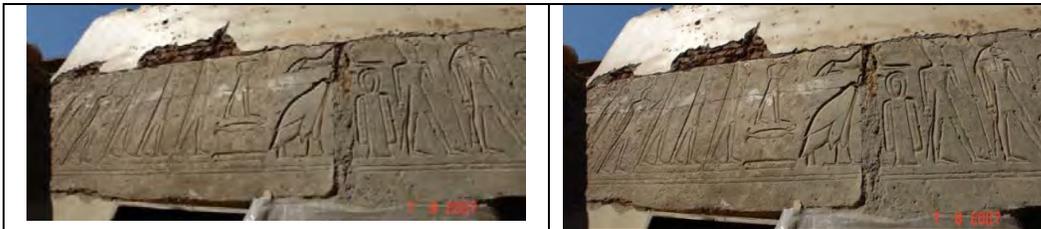
a- The very great pylon, the two great obelisks and the offering which the king gives (to) Re and Atum the lord of .....

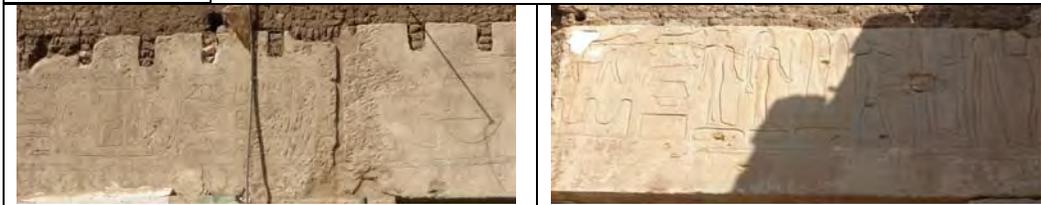
**Fig.23**

b- Who beats the foreign countries, the golden Horus, mighty of years, great of power, the king of Upper and Lower Egypt, lord of the two lands (weser-Maat-Re setep-n-Re) he erected his monuments for his father Amun-Re ..... [as] a resting for lord of the gods in his beautiful Opet festival.

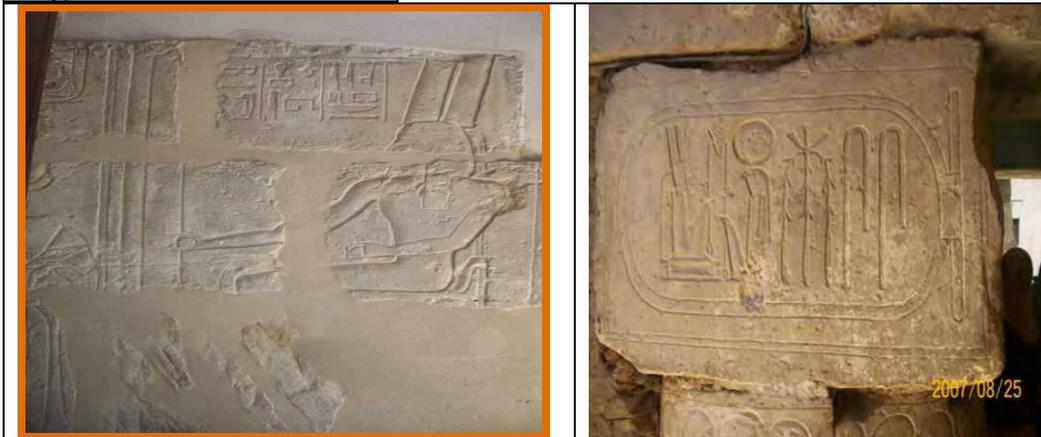
**Fig. 24**

a- Scene represent a king (the head is disappeared) offers mDt- offering to the god Amun a part of frieze the beloved of Amun re who gives life

b- It represent the name of the king Ramses II and on each side upon

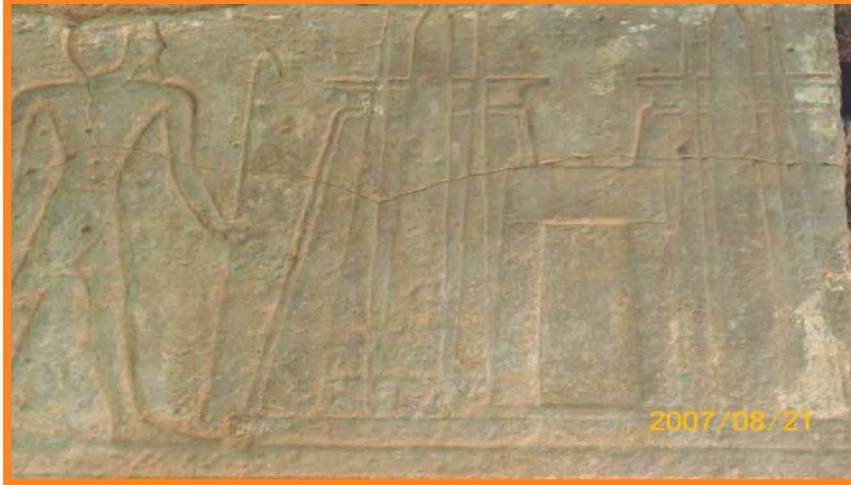
**Fig. 25**

Panel of Entrance design Temple emerged for the first time after removing unoriginal layers
